Roadway Condition Report Route 17 in Delaware County

March 1983

SUBJECT ROADWAY CONDITION REPORT
ROUTE 17 IN DELAWARE COUNTY

FROM L. H. Moore, Technical Services Division, Rm. 210, Bldg. 7A *L.H.M.*
TO James K. Connors, Regional Director of Transportation, Region 9

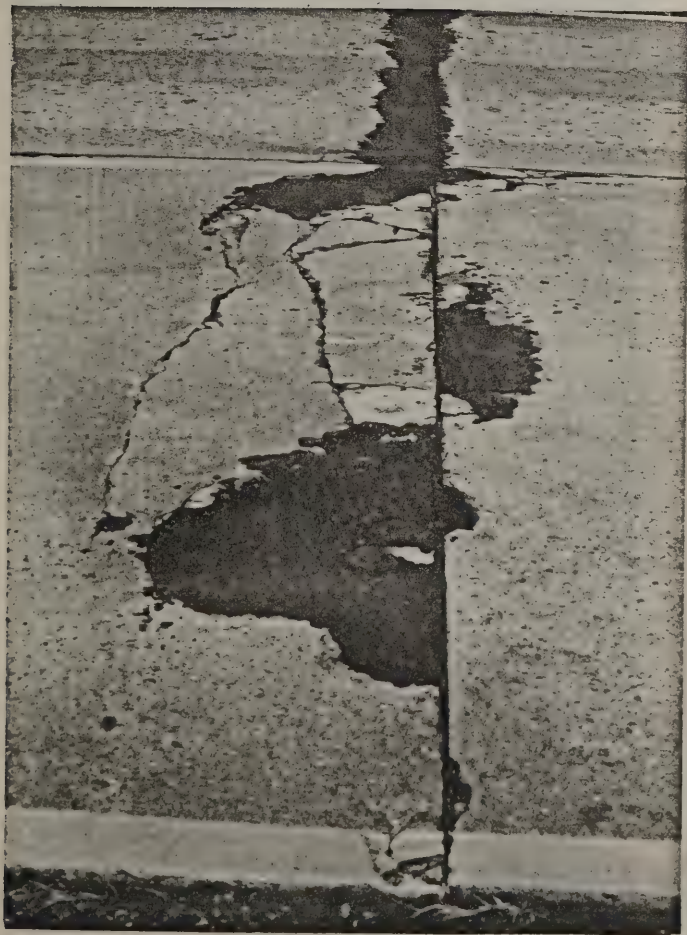
PHOTO 2
Major Transverse Joint
Spalling, Patched by
Maintenance Forces.

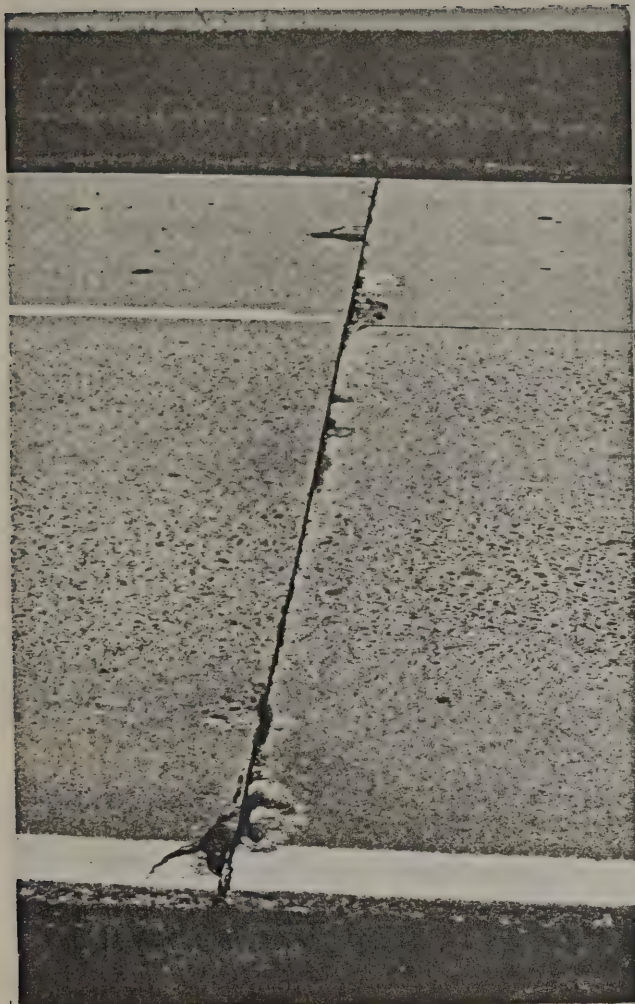
PHOTO 3

Minor Transverse Joint Spalling

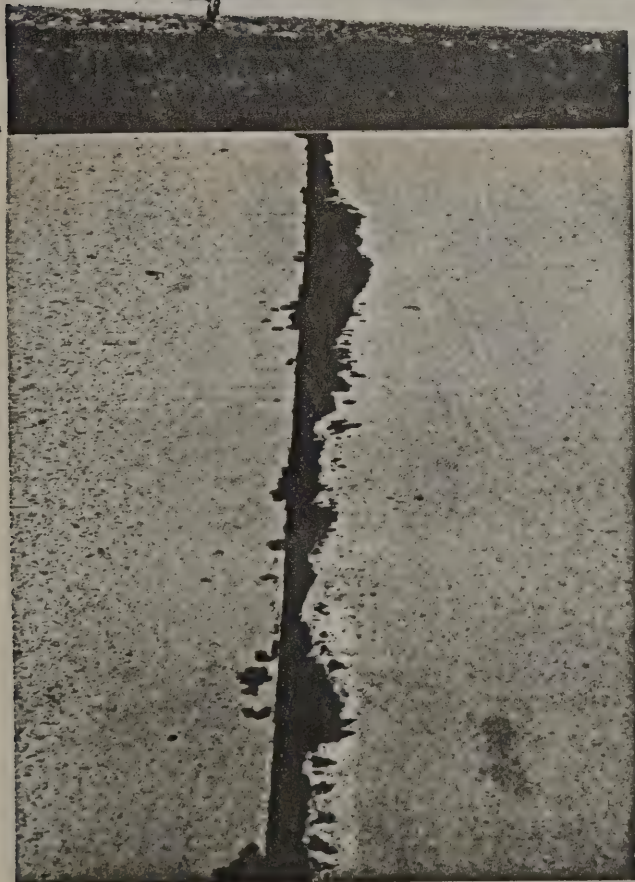
PHOTO 4

Major Longitudinal Joint
Spalling, Patched by
Maintenance Forces

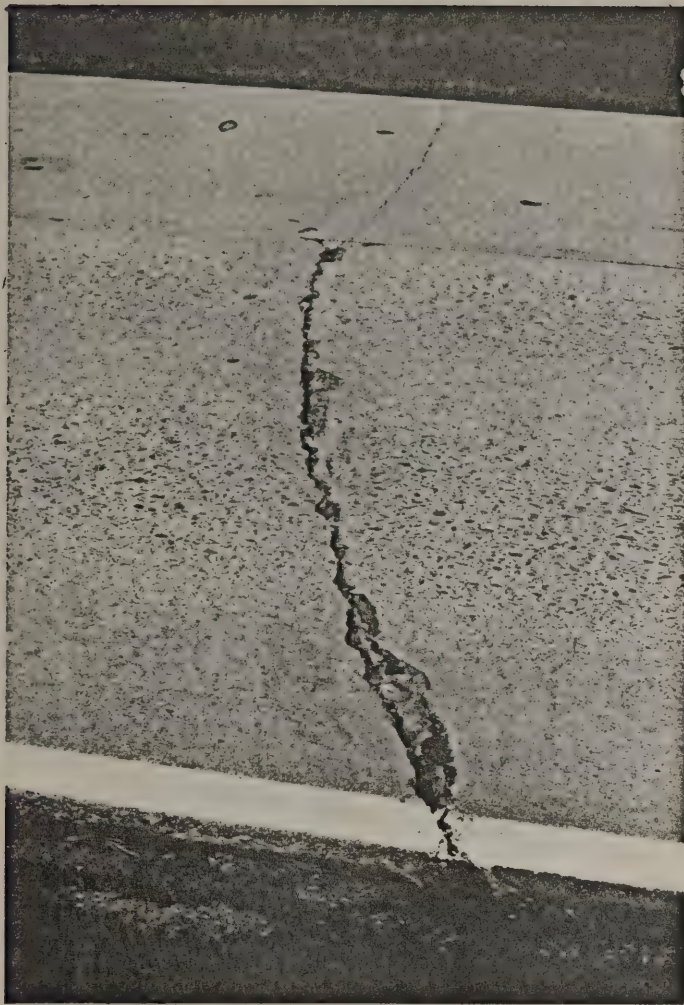
PHOTO 5

Wide, "Working" Mid Slab
Crack Which Has Faulted
and Spalled

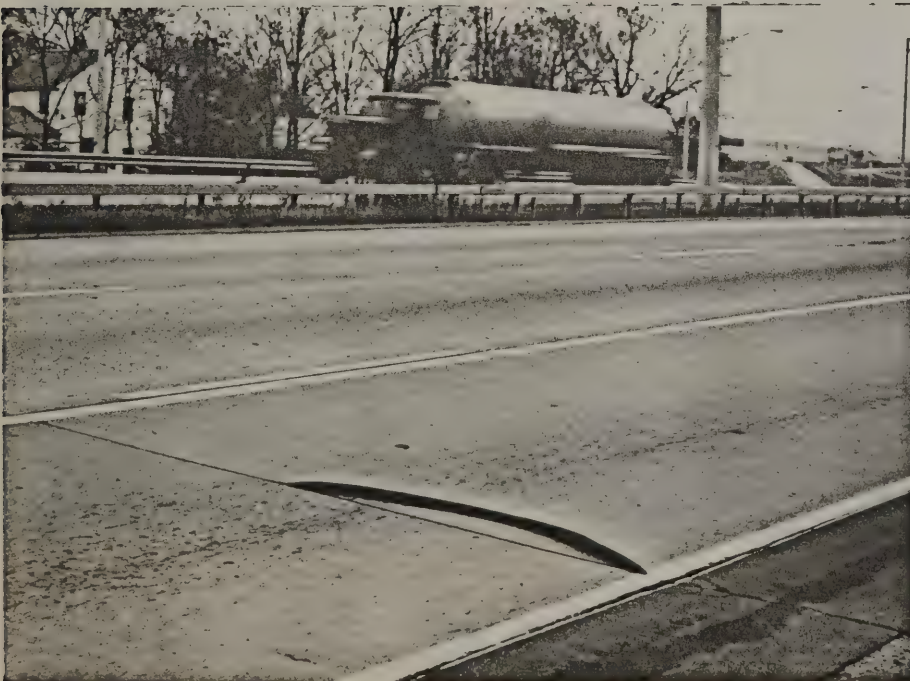
PHOTO 6

A Failed Preformed
Neoprene Extrusion
Lost From a Trans-
verse Contraction
Joint

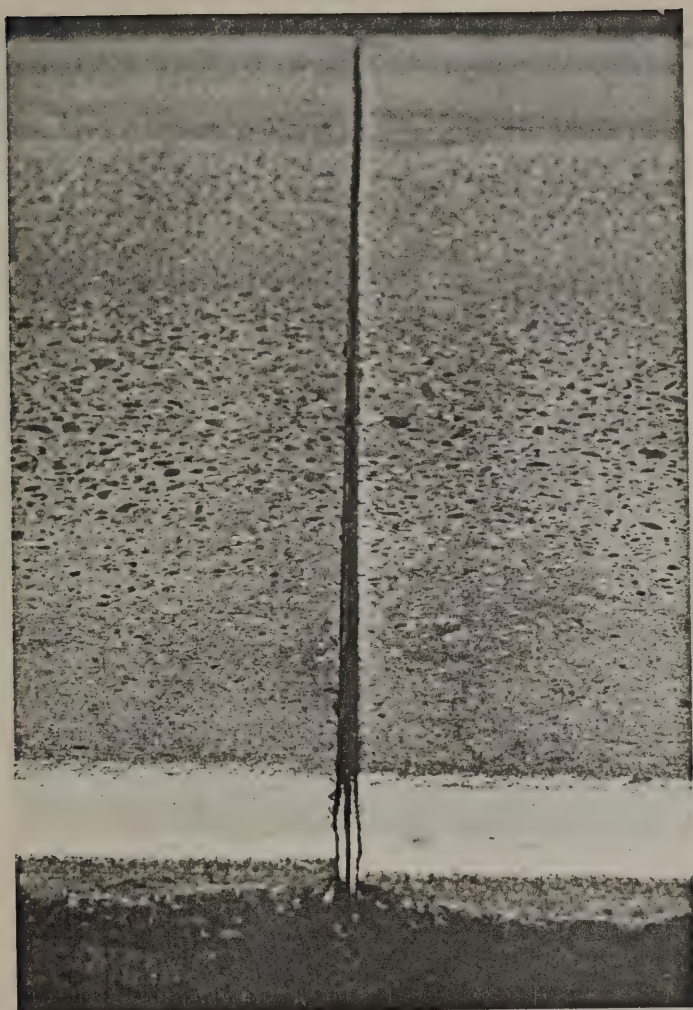
PHOTO 7

A Preformed Neoprene Extrusion
Still Sealing a Transverse
Contraction Joint

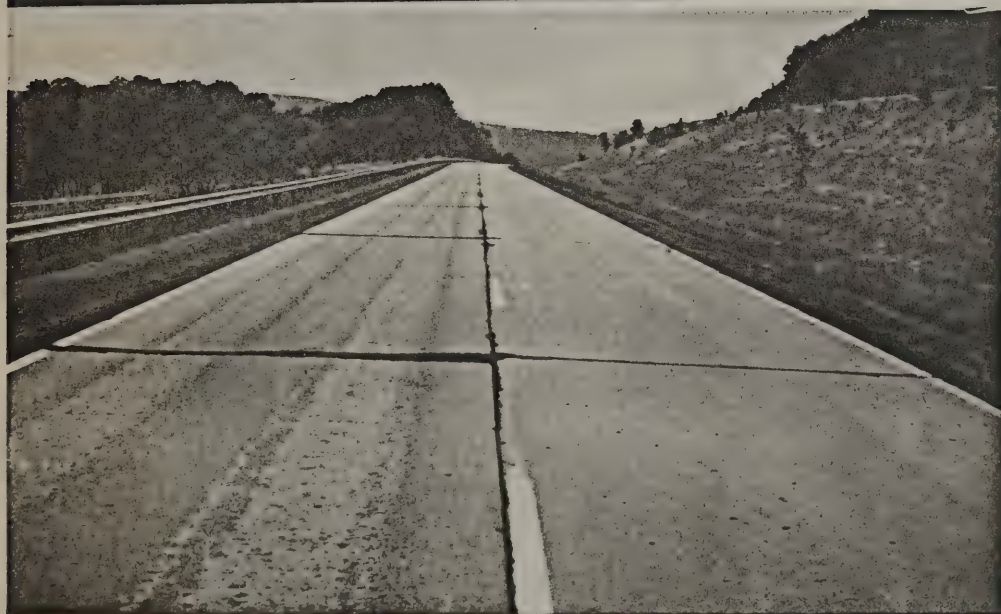
PHOTO 8

View toward oncoming traffic.
Wheel track Ruts in the Driving Lane.
Note, the Transverse Joint Faulting
that has occurred in this lane also.

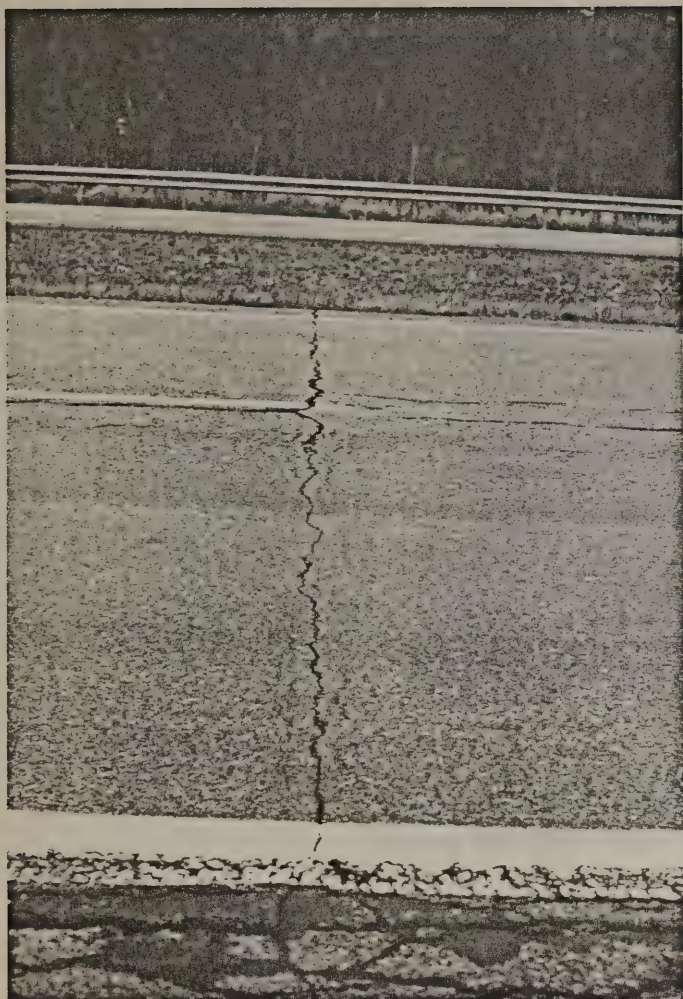
PHOTO 9

Transverse Reflective
Cracking in an Asphalt
Overlay

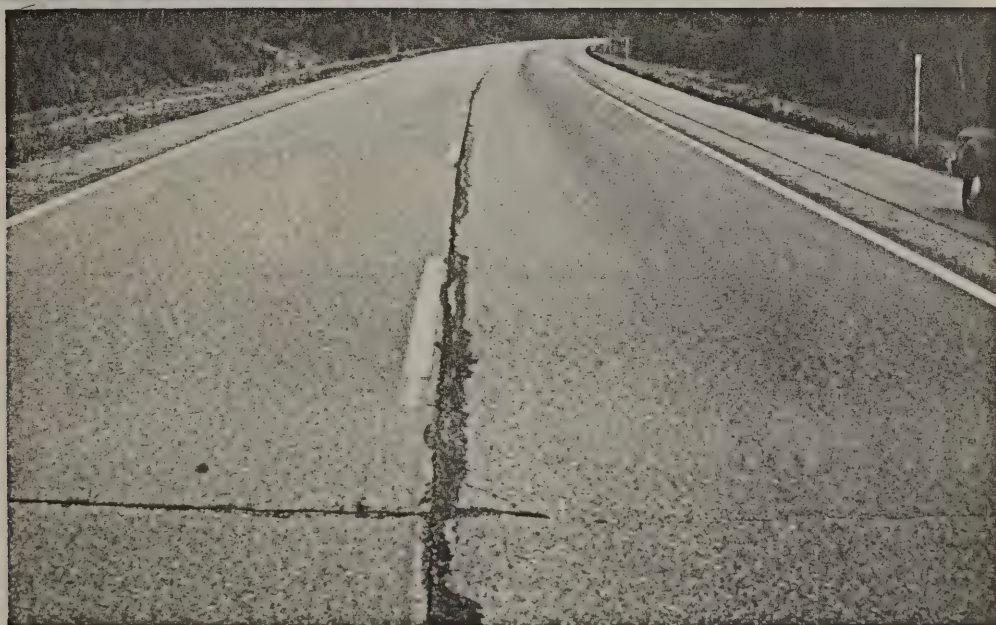
PHOTO 10

Longitudinal Reflective Cracking
in an Asphalt Overlay, Patched By
Maintenance Forces.

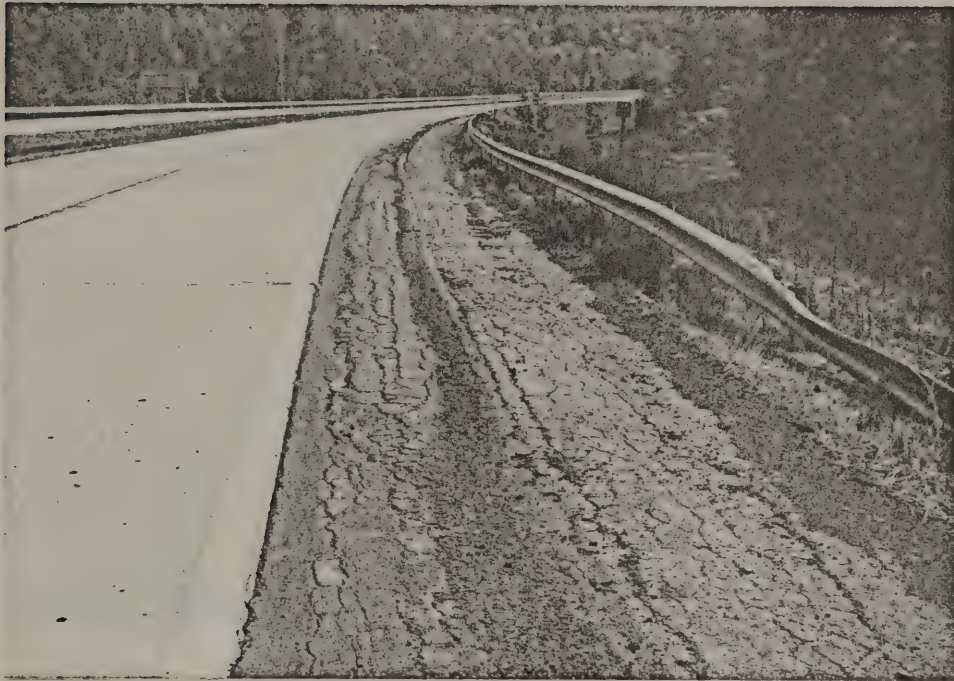
PHOTO 11
Alligator cracking and sand accumulation
along outside edge of shoulder.

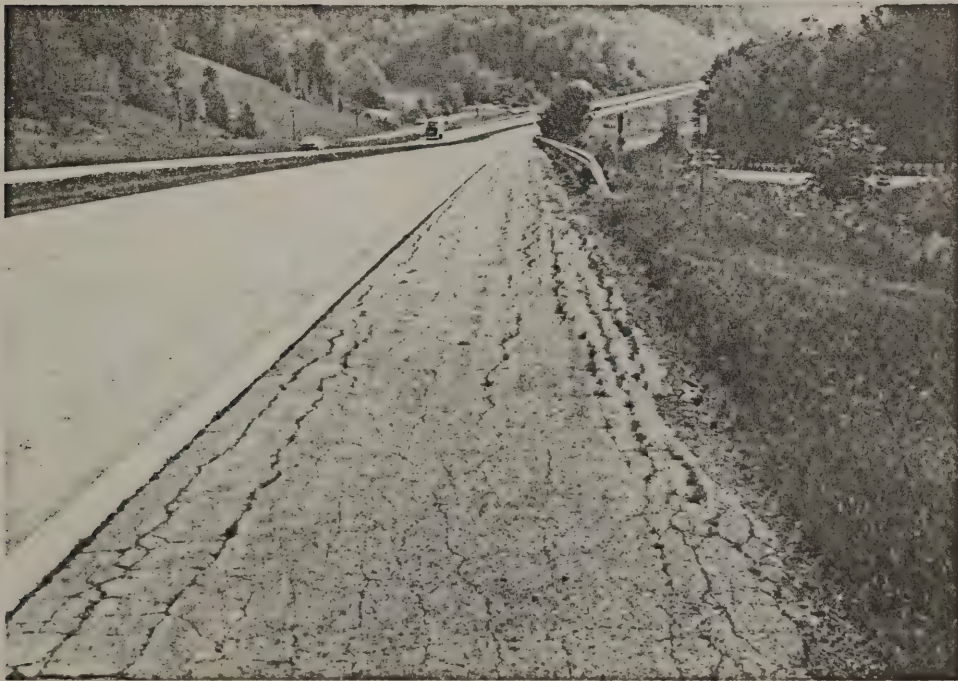
PHOTO 12
Alligator Cracking

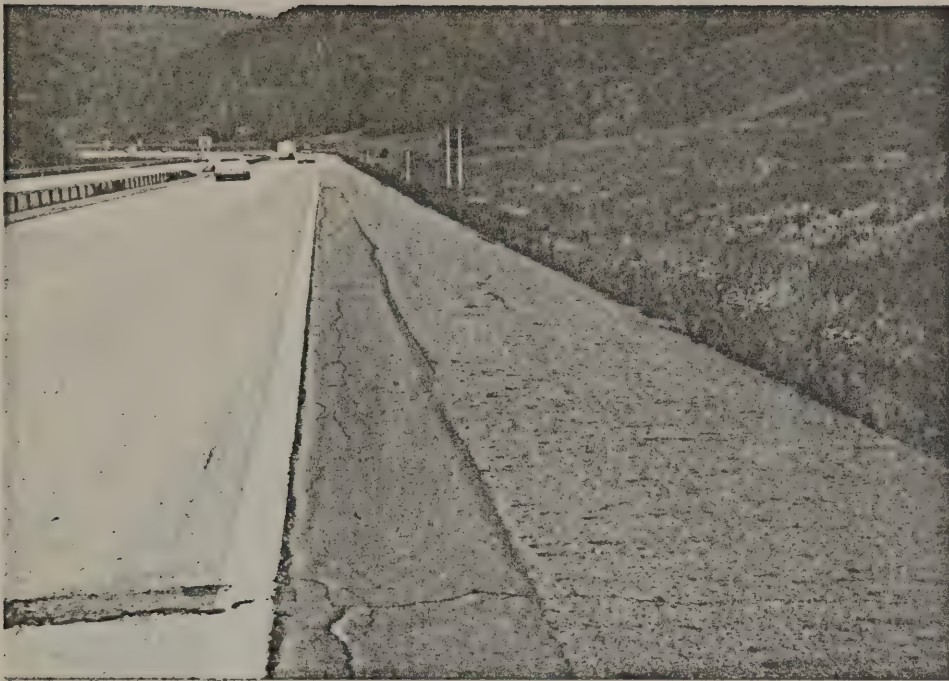
PHOTO 13
Two to three foot wide shim course
at the pavement shoulder interface.

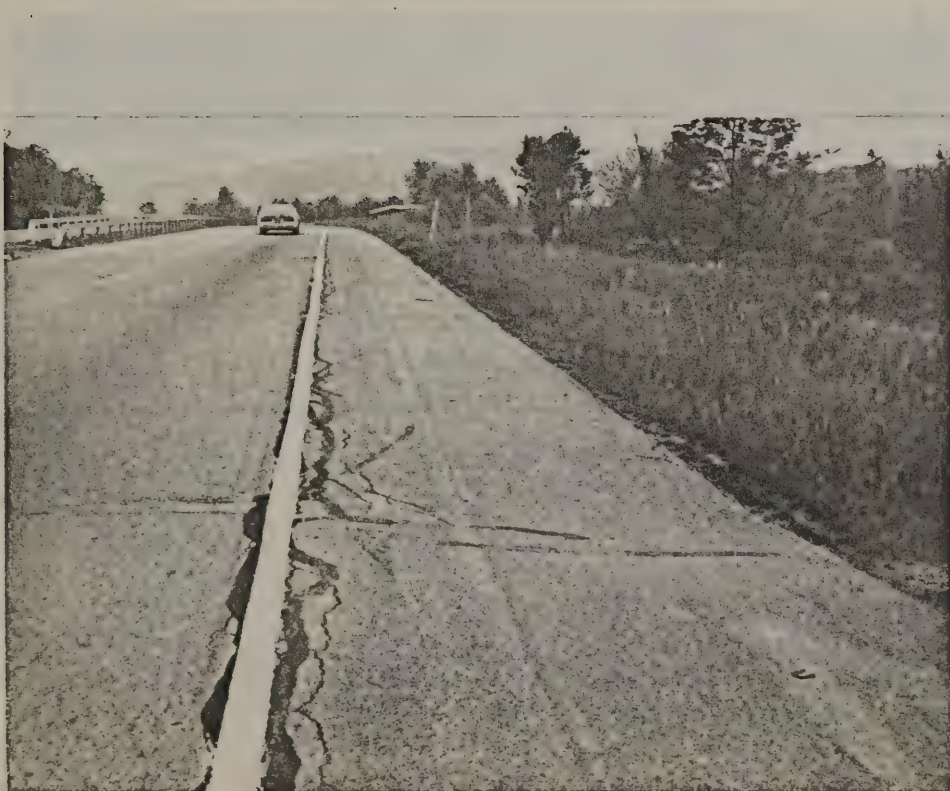
PHOTO 14
Attempt at sealing cracks along
the pavement shoulder interface.

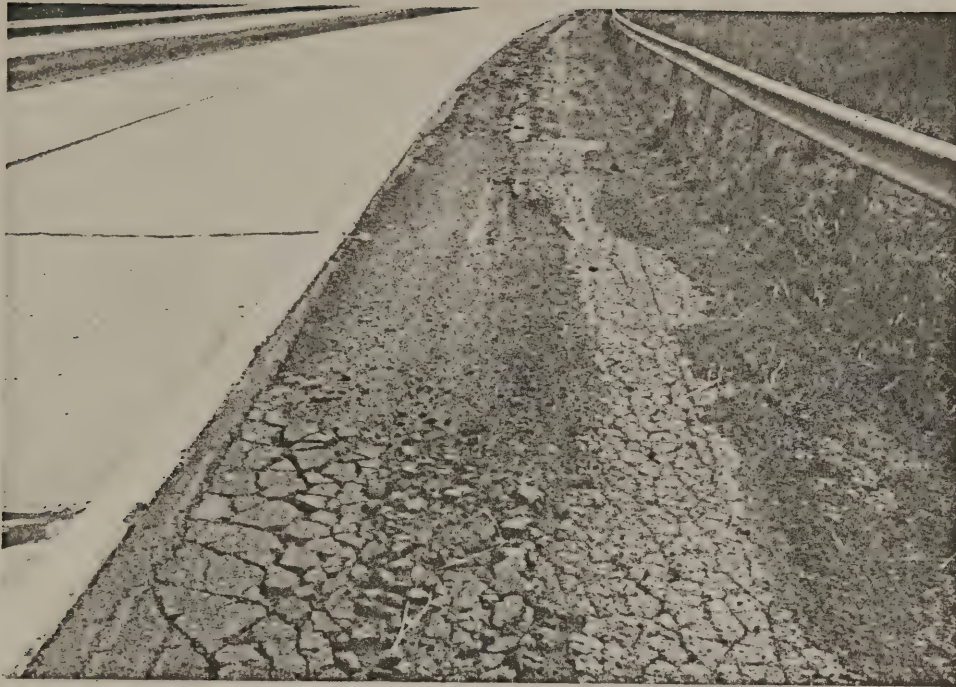
PHOTO 15
Completely disintegrated shoulder with
droff at pavement shoulder interface.

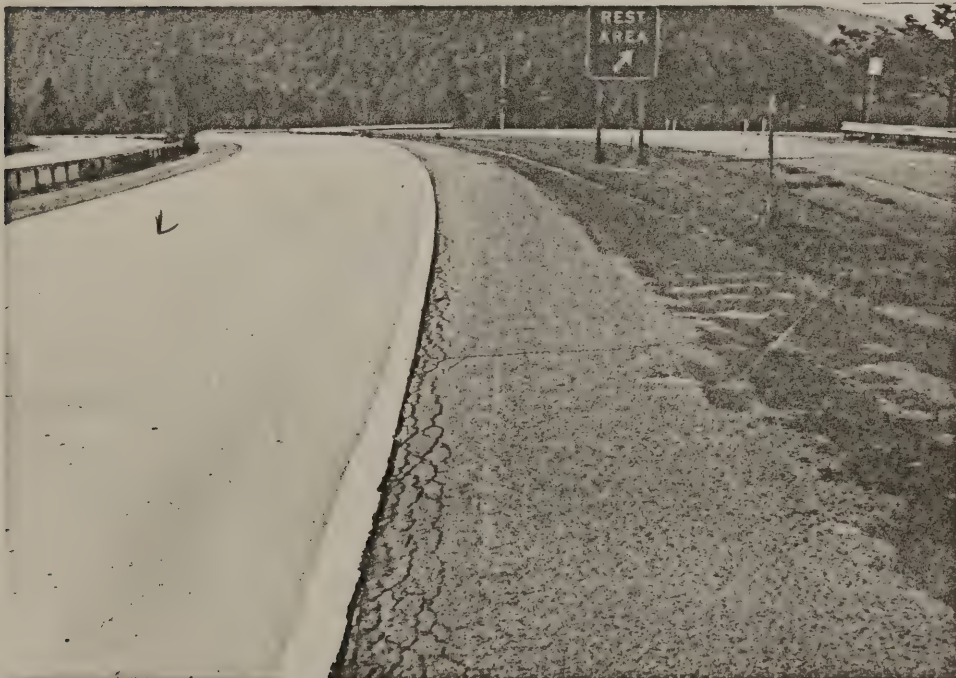
PHOTO 16

Typical cracking one to two feet
in from the pavement shoulder interface.
